CLOSE OUT REPORT

Phase 1

Infrastructural Improvements to ECD Centres in Msinga and Nquthu

KwaZulu-Natal

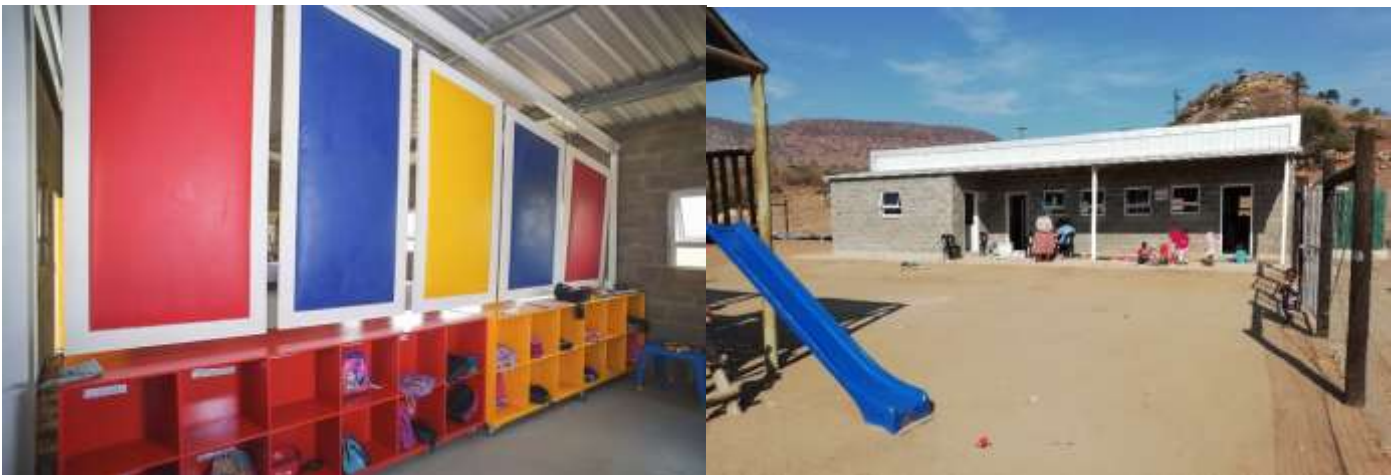
Figure 1: Internal partitioning in progress

Completed ECD centre

Lima designed a range of New Build facilities from 1 classroom up to 4 classroom units. Both the National Building Regulations as well as the Department of Social Developments ECD infrastructure guidelines were considered. The DSD documents stipulate the classroom space requirements per child, and the requirements in terms of office, kitchen sickbay and storage. The aim of this design was that it needed to be appropriate for a range of local conditions, as well as being a cost effective solution with low lifespan costs. Lima proposed a modular steel portal design. Although this may be seen as excessive, the building element with the greatest failure rate in this region was the roofs as a result of wind damage. The modular design of the building would also accommodate future expansion opportunities. Lima also proposed a moveable partition system between the classrooms. This would allow for better functionality of the space, as it could be converted into a "hall" if required. A Clere-Storey sidewall cladding was used in the new builds to promote natural lighting.

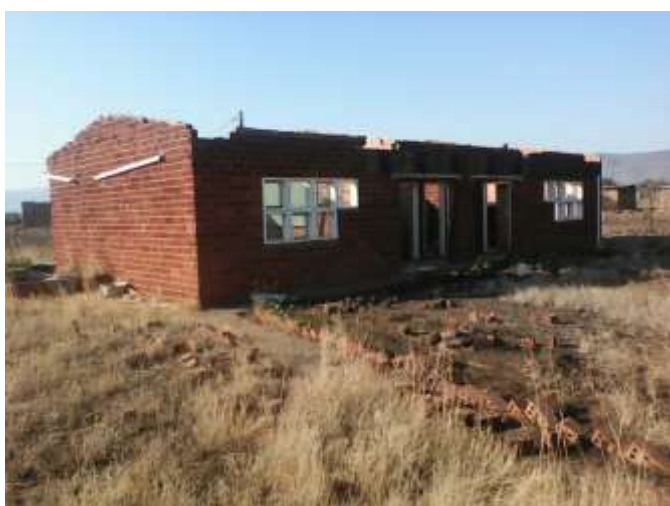
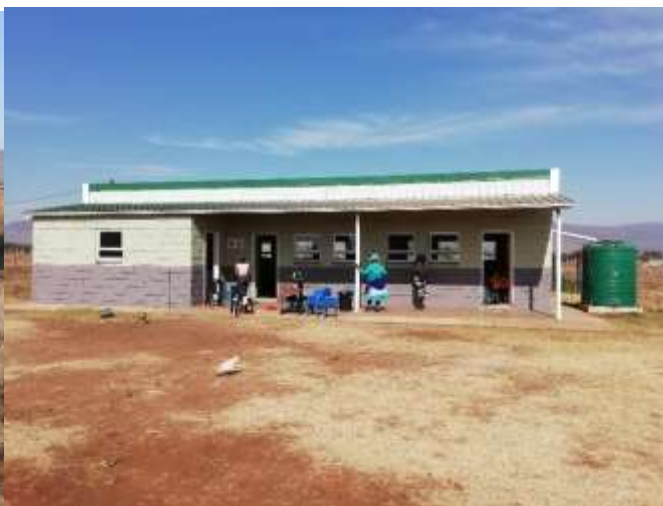
Figure 2: Vukuzakhe before

Vukuzakhe after

There were significantly more new build facilities required in Nquthu with 12 units, as opposed to the 5 units required in Msinga (excl. Sinozwelo). This was due to the existing infrastructure being in a better condition in Msinga than in Nquthu. Figure 2 below shows Vukuzakhe's (Msinga) old structure with a number of structural defects and the new structure thereafter.

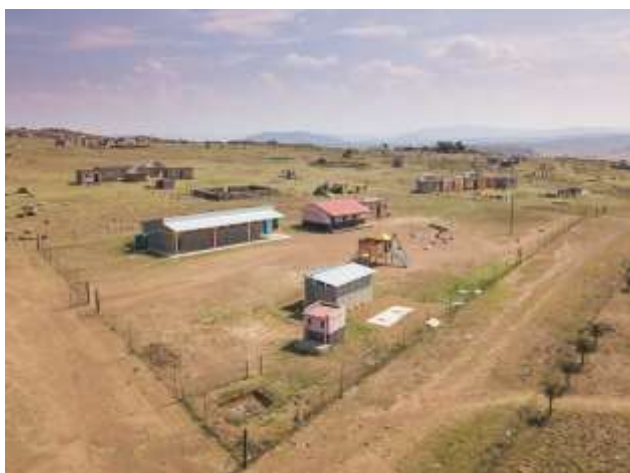
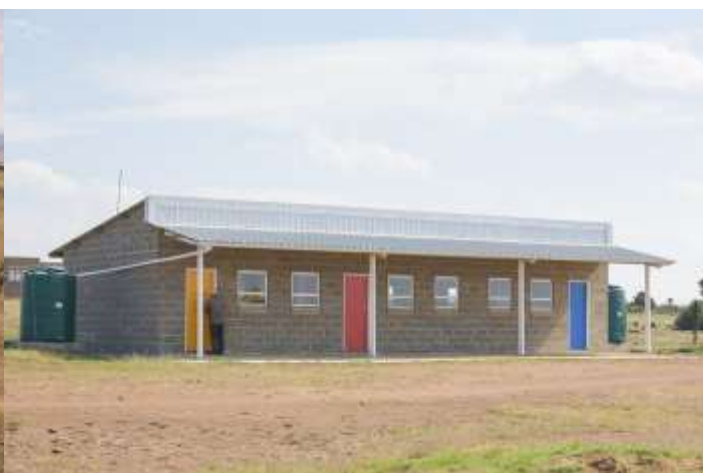
Figure 3: Qhapelani complex

Figure 3 below shows the 3 classroom extension at Qhapelani (Nquthu). The existing small multi-purpose space was converted into an office and kitchen, and 3 new classrooms were provided.

3 new classrooms at Qhapelani

The major lesson learnt was the request from the EHP to plaster and paint the building. This was not part of the original scope, and Lima ended up plastering and painting the kitchen. However, in future work that Lima does, the facilities will be plastered and painted. The original plan was not to plaster and paint the units to reduce ongoing maintenance costs for the centre. However, by rendering the building, there will likely be a reduction in the amount of dust in the facility.

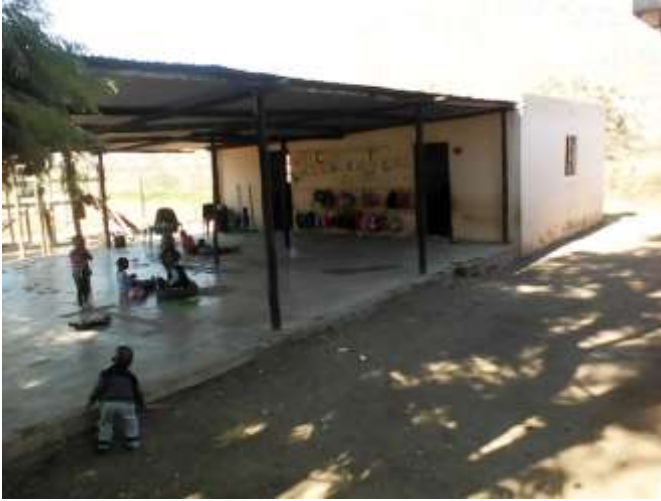
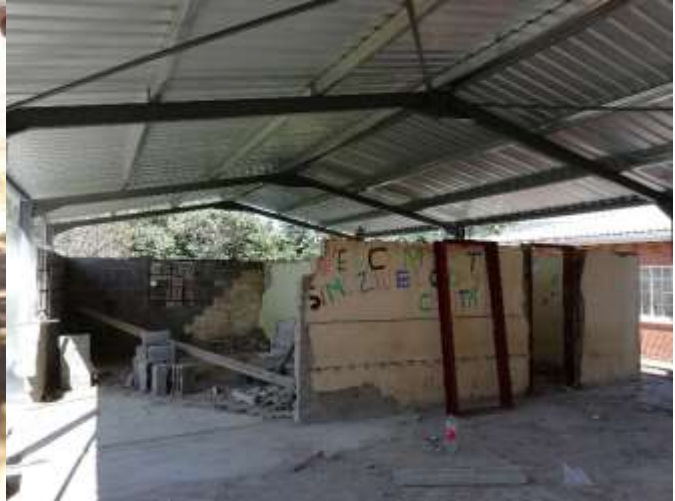
Figure 6: Sinozwelo prior to construction

Sinozwelo during Construction

Sinozwelo is an example of a major repair. This centre had approximately 100 children, with limited space. It was decided that some of the existing building would be retained and incorporated in the new facility. This proved to be problematic and costly as the foundations of the existing building were virtually non-existent and needed to be underpinned. It would have been cheaper to completely demolish this building and build a new structure. However, an effective solution to space limitations was obtained, and the space is able to be used as both internal and external space.

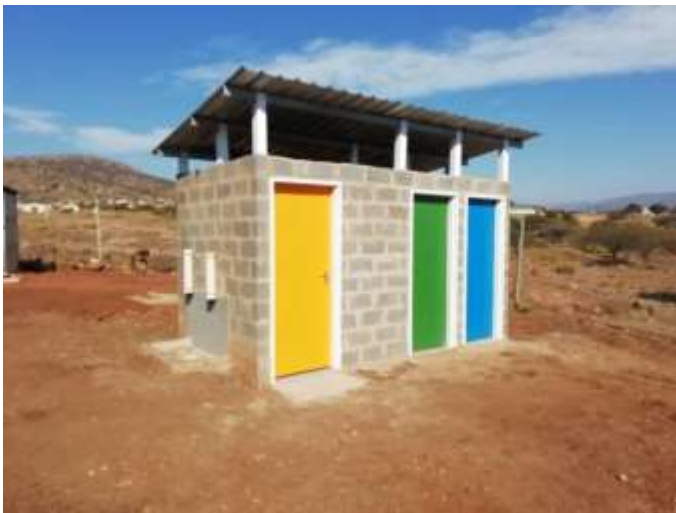
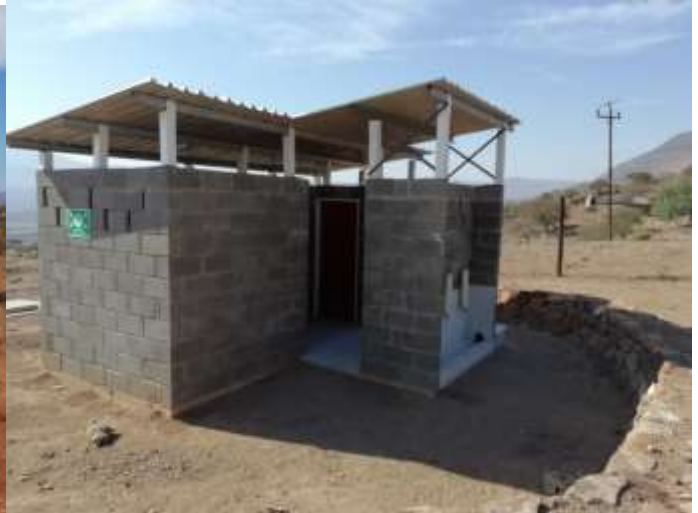
Figure 8: 3 stall unit at Esibusisweni

4 stall unit with urinal at Nqgongeni

On the new toilet facilities, Lima made use of a pour-flush toilet option, which, as previously mentioned, only used 1-2 litres of water per flush. This was extremely well received by the crèche's. For a pit toilet to be effective, it has to be dark to limit flies. Young children normally find this to be a rather intimidating environment, and it was observed in a large number of the centres that the children chose to go outside rather than use a pit toilet. This arrangement has been turned around with the introduction of the pour flush system, and the centres have confirmed that the children are now choosing to use the toilets.

Lima has also tried a few hand-wash options, with some of the options being more durable than others. The 110mm waste-pipe option is the most durable. Lima will continue to look at options for the taps. Lima also used 2 options for the sanitation facility, a smaller 3 stall unit for the smaller centres, and a larger 4 stall unit with urinal for the larger centres.

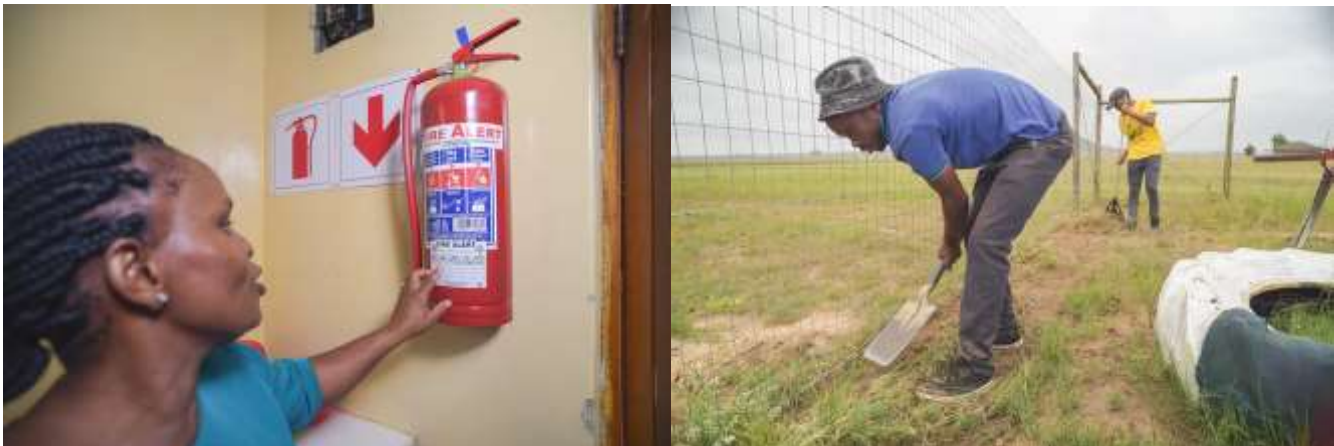
Figure 10: Fire extinguisher and signage

Fence installation

Health and safety infrastructure and equipment included fencing, a fenced waste pit, fire extinguisher and signage, as well as first aid signage.

There were a few items that weren't adequately considered in the initial assessment. The first is that the fence length was catered for just the play area and not the entire property, as the DSD norms require a fenced play area. However, this was strongly resisted by all the crèche practitioners, and the entire yards was eventually fenced. The second item which was not initially considered was the fenced waste pit. This was identified during the project by the EHP's, and included in the scope.
